Ken Robbins
Highway Administrator

Weekly Report to Commissioners

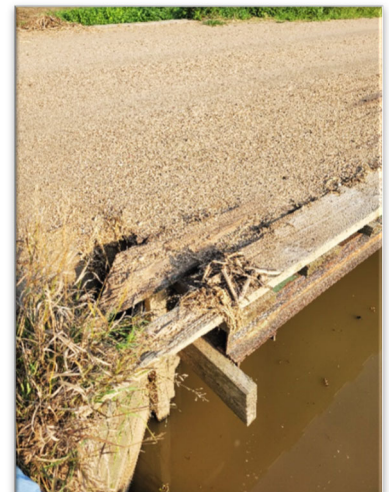
- 130 Road 1/10-mile North of Elm Road. Erosion has undermined a bridge abutment and some repairs are necessary before it can be backfilled.

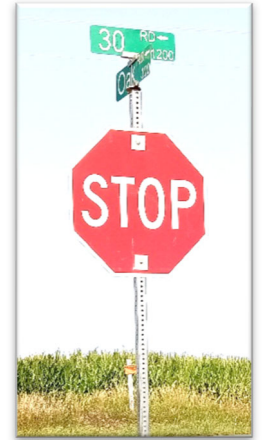
- The Roads and Bridges Department is committed to replacing a minimum of 2 signs each week. *Signs were replaced at King & 200, Fir & 30, Oak & 30 (picture right), and 130 & Nickel Roads.*
